Demonstration and Assessment of a Sulfur Lamp Retrofit Lighting System at Hill Air Force Base, Utah

**Eric E. Richman, Judith H. Heerwagen, J. Bradford Hollomon
Pacific Northwest National Laboratory**

Summary

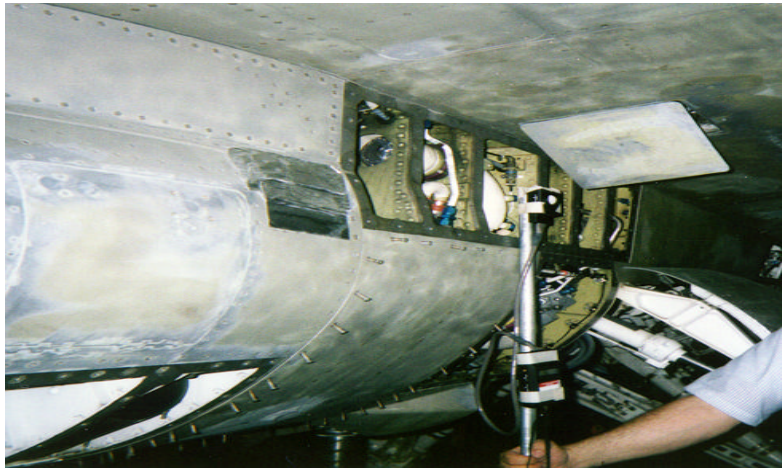
Figure 3. Vertical Foot-candle Measurements - Under Wing

Light level readings (in foot-candles) were taken 30-in. off the floor and 100-in. off the floor. Each set of measurements was taken at specific points on a grid covering the test areas. The Dock 45 test area covers a total of over 17,000 square feet with 66 measurement points on a 12.5-ft by 12.5-ft grid. The grid was laid out and marked on the floor. Tripod and a pole, or stair units with level bubbles attached, were used to get reasonably accurate measurements at 30-in and 100-in. Vertical foot-candle measurements were also taken at critical maintenance points below and above the wings of the aircraft. Figure 3 shows the format for these measurements. Measurements were taken with a Minolta T-1 illuminance meter.

A graphical presentation of the Light Drive™ 1000 lighting of Dock 45 at 100 in. from the floor is presented in Figure 9. In this figure, the location of the aircraft is not as obvious as in Figure 3 because the readings are taken above most obstructions.

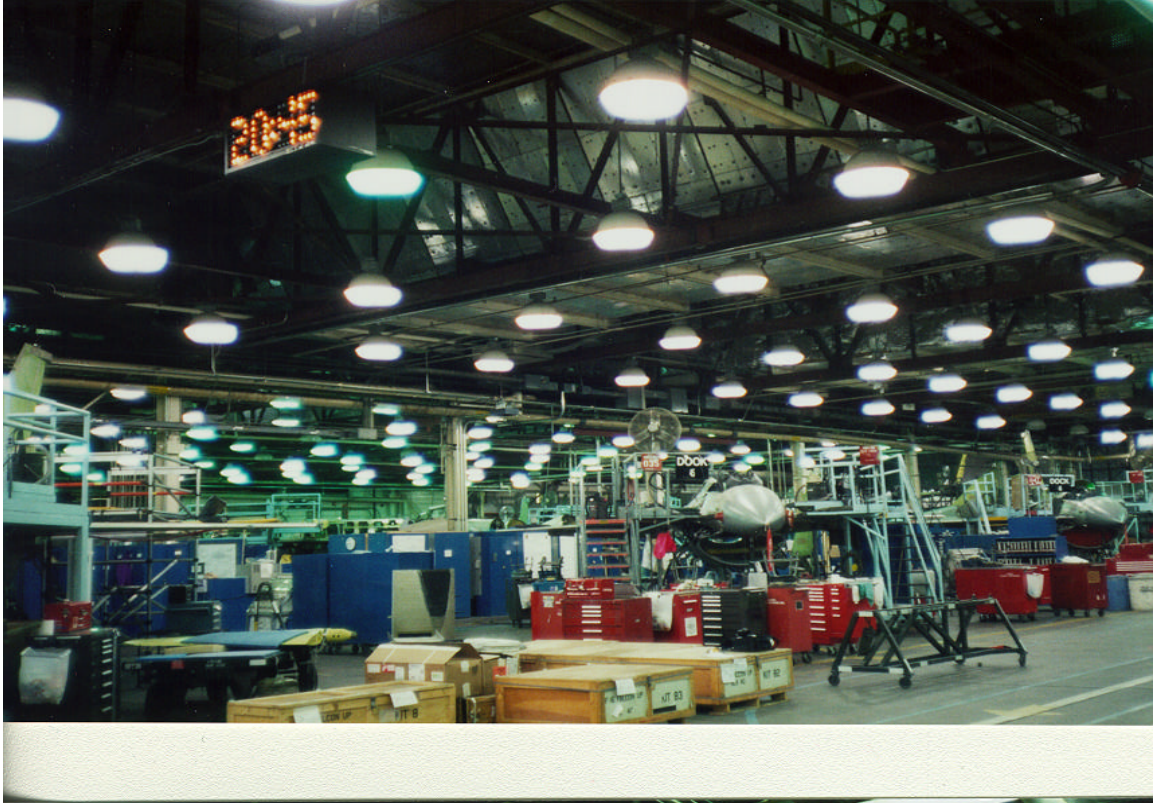
Figure 6. Post Retrofit Illuminance (fc) at 30" from floor in Dock 45 (F16) w/equipment moved away (filled data)

by equipment, show reduced lighting levels because of side shadowing of neighboring equipment.

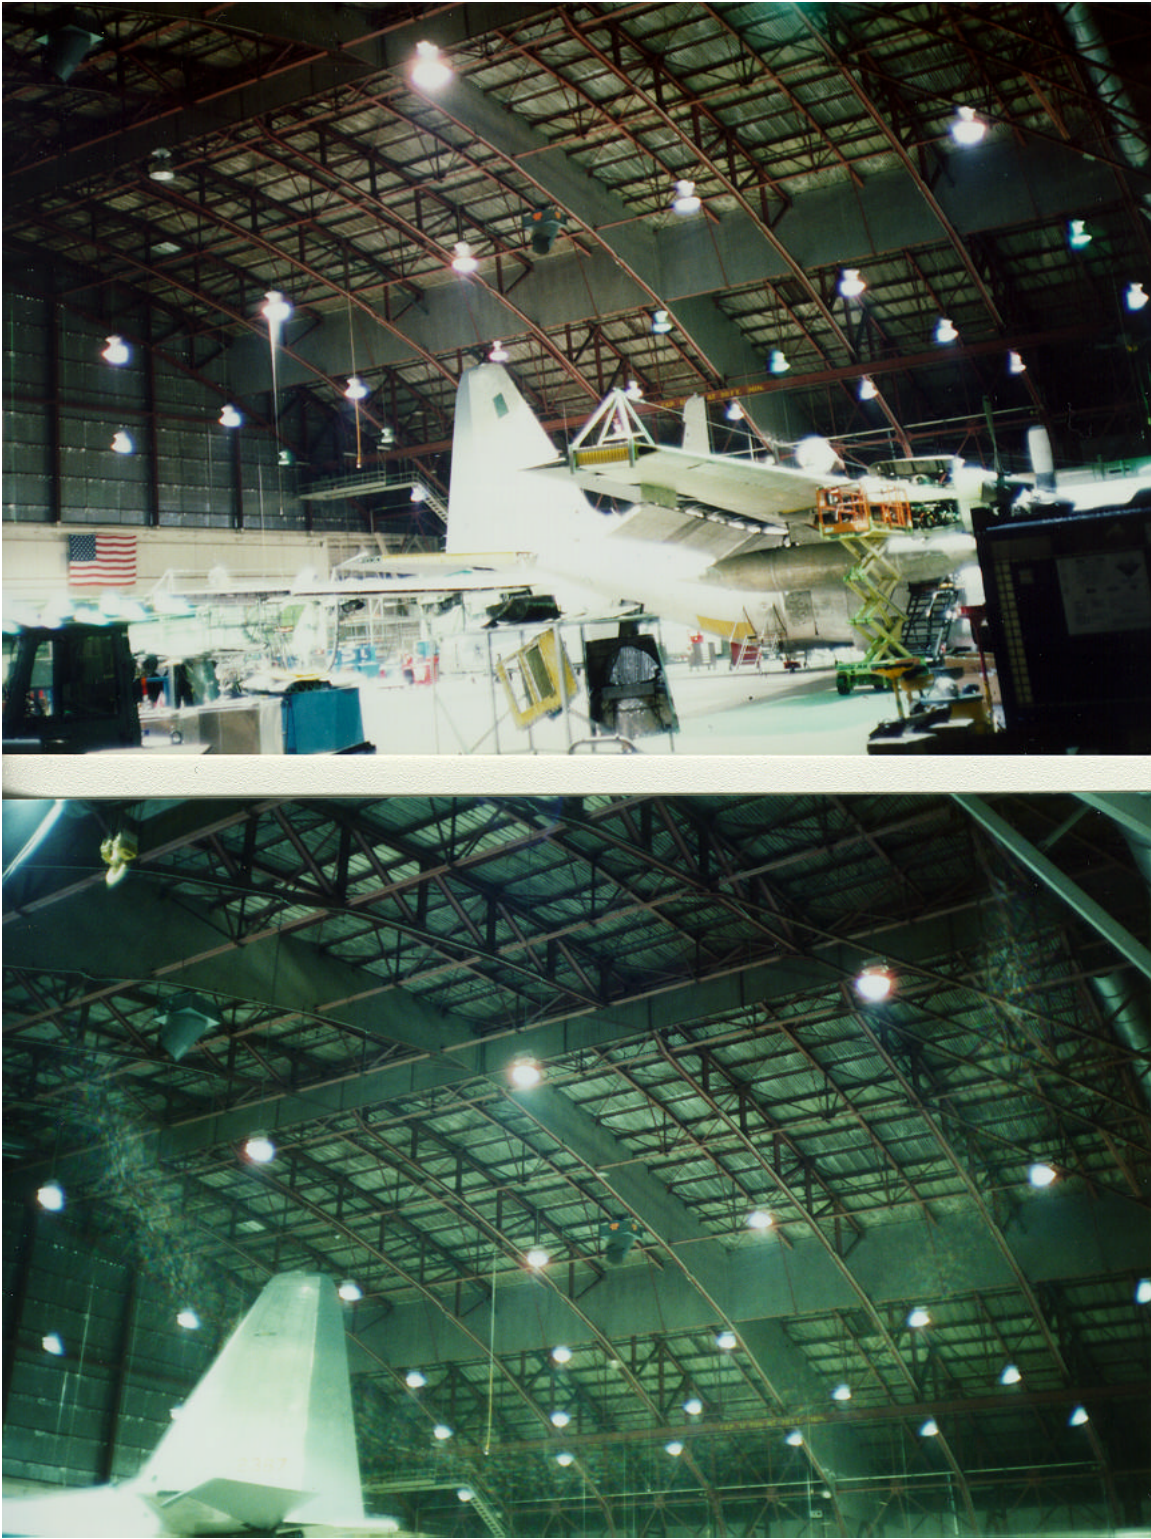
Figure 11. Pre- (top) and Post- (bottom) Retrofit - High-Bay

Figures 11 and 12 are photographs show a comparison of the test space between pre- and post- retrofit from two viewpoints.

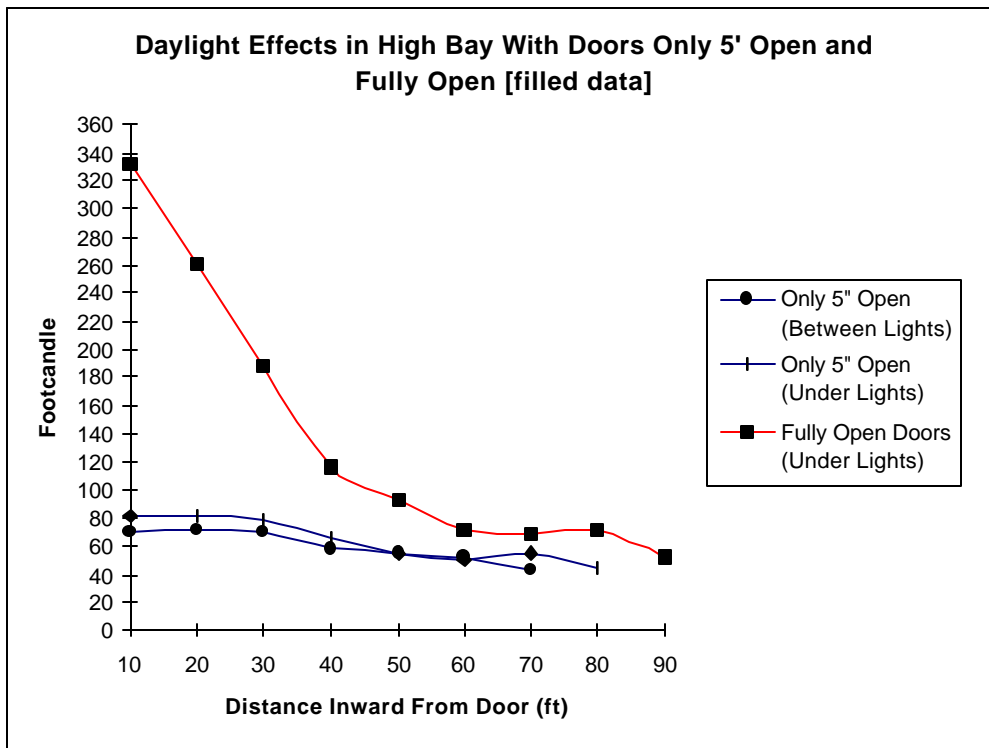
A characterization of the contribution of daylight within the hanger space is shown in the chart below. The daylight contribution to the light level directly on the floor when the door is fully open is greatly reduced after approximately 60 feet in from the hanger door. However, the contribution at this point is still approximately 20 foot-candle above the light level provided by the pre-retrofit lighting. The daylight contribution with the doors partially open ranges from doubling the pre-retrofit artificial lighting level near the door to an insignificant contribution at between 50 and 60 feet into the hanger.
